Manhole Inspection Summary

Manhole # S31S__010MH

Insp Date: **9/2/08 10:44 AM**

Location Address: **s sharp st**

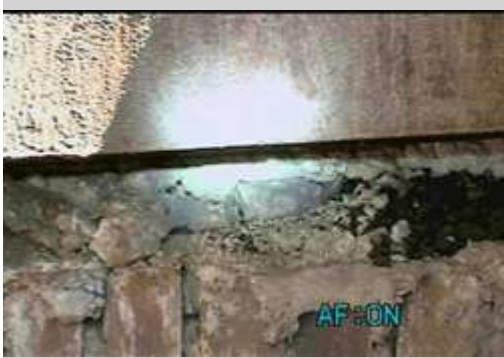
Defect 2

Condition: ☐ Sound ☐ Cracked ☐ Root Intrusion ☒ Loose Brick ☒ Deteriorated

chimney cond loose bricks, chimney cond deteriorated

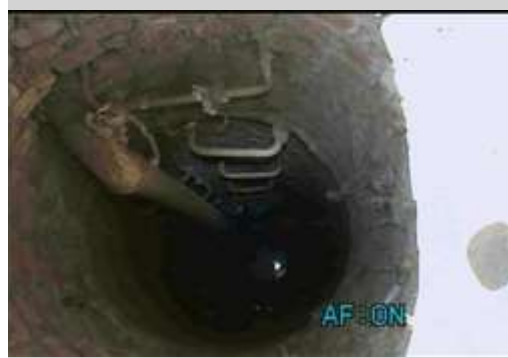
Defect 1

Count: **11** Missing: **0** ☒ Corroded

steps

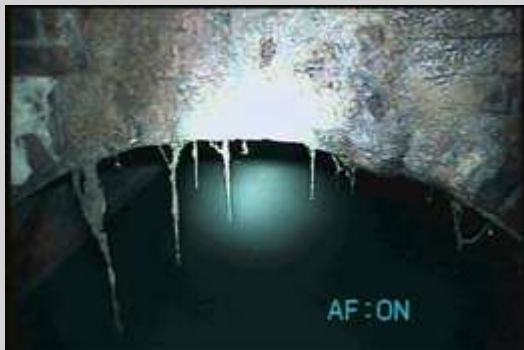
12 O'Clock Outflow

54 in. Circular Gravity Sewer
Pipe Out @ 12 O'Clock

Pipe Material: **Concrete** ☐ Pipe Lined

Invert Depth: **16.80** (ft.) Flow Characteristics: **Slow**

Deposits: ☒ None ☐ Mud ☐ Sludge ☐ Debris ☐ Grease

Infiltration: **None** Pipe Seal Cond: **Unknown**

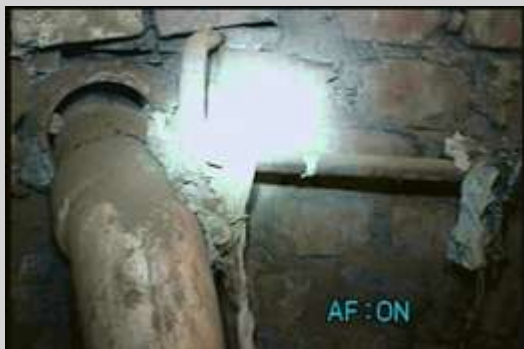
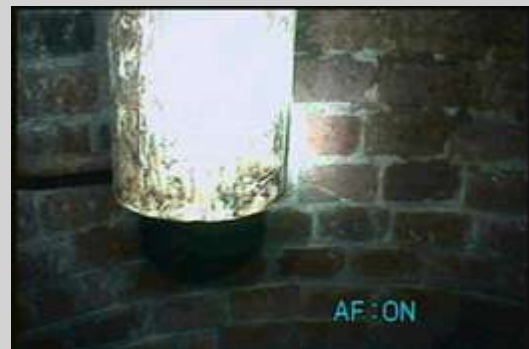
2 O'Clock Inflow

8 in. Circular Gravity Sewer
Pipe In @ 2 O'Clock

Pipe Material: **PVC** ☐ Pipe Lined

Invert Depth: **2.90** (ft.) Flow Characteristics: **None**

Drop: **Outside Direct**

Inv Depth: **10.50** (ft.)

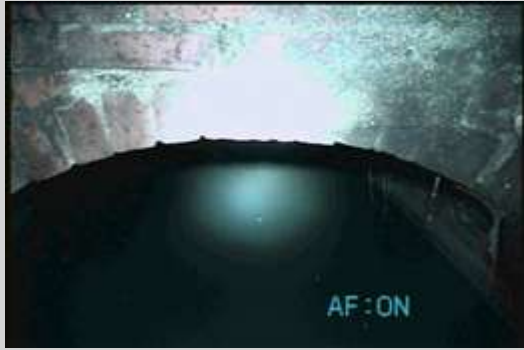
6 O'Clock Inflow

54 in. Circular Gravity Sewer
Pipe In @ 6 O'Clock

Pipe Material: **Concrete** ☐ Pipe Lined

Invert Depth: **16.60** (ft.) Flow Characteristics: **Slow**

Infiltration: **None** Pipe Seal Cond: **Unknown**
